# Damp room to wet room

**Mike Wye & Associates are specialists in the repair of, and the supply of materials for, traditional buildings. Paul Watts from the company writes about one room of a 17c property that received a make-over whilst avoiding some of the common pitfalls.**

When the owners of Tyrella House, a mid to late 17c Devon cob and stone dwelling, needed to refurbish one room into a wet room, they chose to take a sympathetic approach to the needs of the building as well as the inhabitants. This article tells of the materials used and how they created a warm, modern condensation free facility that is in perfect harmony with the building.

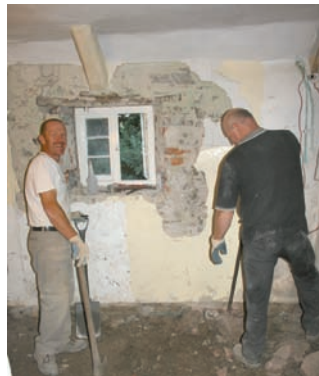
*Graham and Bob preparing the room by removing the cement plaster and flooring – the lintel over the window can now be seen to be failing*

The first job was to hack off all the inappropriate materials to get it back to the bare walls and allow them to dry out. Exposed holes were then filled using lime putty mortars and a couple of wooden lintels replaced.

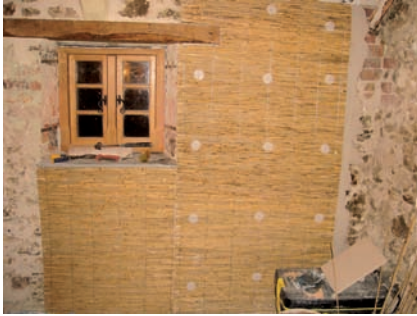
*New lintel and bespoke window fitted – reed insulation being fitted with lime mortar backing*

The window was really beyond repair but the style was recreated in oak by a local specialist joiner, Woodpecker Joinery. A lovely job was made of the window and cylinder glass was sourced to give it a hint of age. This glass is difficult to obtain but has blemishes from manufacture that create a shimmer not present in modern glass. Consideration to this type of detail should always be given if character is to be retained in an old building.

The other outside wall was not as level as the first and Reedboard was used instead. This is a little less thermally efficient with a K value of 0.054W/mk but it can follow the contours of the wall better and thus retains more of the original character. All too often a make over of this kind can totally lose the character of the room and an important part of the philosophy of this renovation was that it would not look like just any other modern wet room. Hence not all choices were based on maximising the insulation properties of the room. The labour involved in fitting reedboard can be greater than the wood fibre board and, as there is less suction, the initial plaster backing needs to be left longer before the lime skim coats are applied.

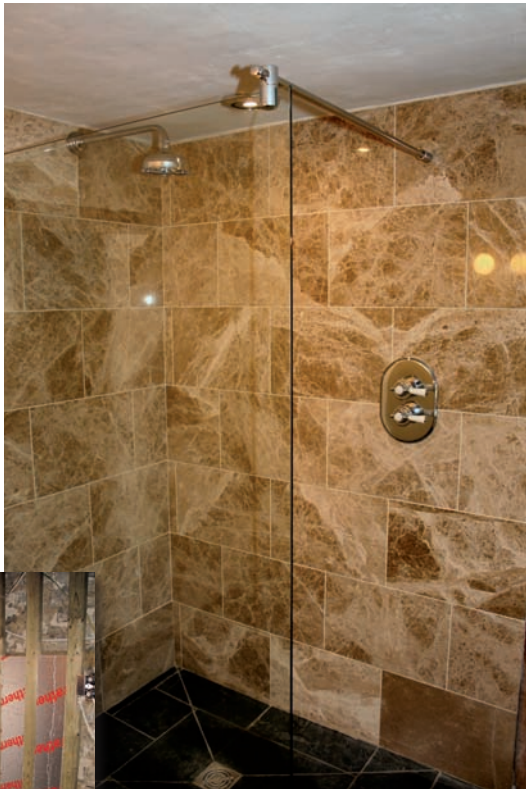
*The shower area studwork fitted away from the stone wall with modern insulation between the studs*

With the outside walls dealt with, the internal partition walls were next to receive the make-over treatment. Much of the remaining wall space was to be used for the shower area. Insulation is still a good idea around the shower but a natural, breathable insulation is not required or necessarily desirable. The wall however, is still without a damp proof course and has the potential to draw dampness up from the ground and build up problems behind the insulation and tiles. In this instance, a stud partition was erected a few inches away from the wall. This allowed services to be run behind and moisture vapour to vent away up the wall and be removed via the mechanical extraction system. ▷

Xtratherm was used between the studs and a cementitious, insulating Wedi board fixed to the front of the studs before the marble tiles were fixed with adhesive and sealed.

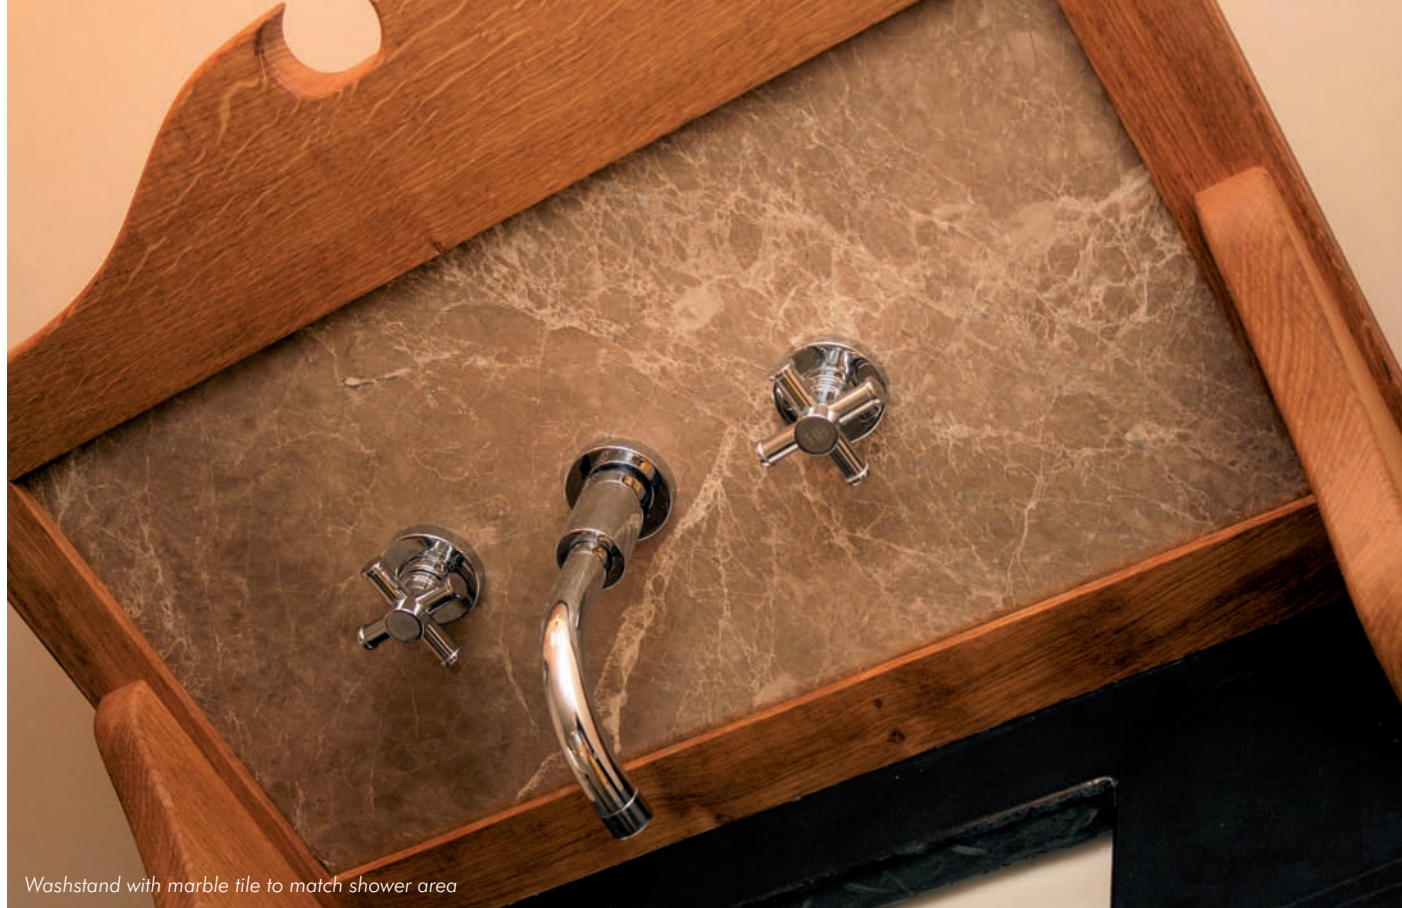
Washstand with marble tile to match shower area

The owners wanted to add a little more individuality to the room, so once more Woodpecker Joinery made a bespoke oak wash stand and a pine cistern box was made to house a rubber cistern picked from the local recycle centre for £10. All the wood was finished with Kreidezeit Base Oil and then Hard Oil.

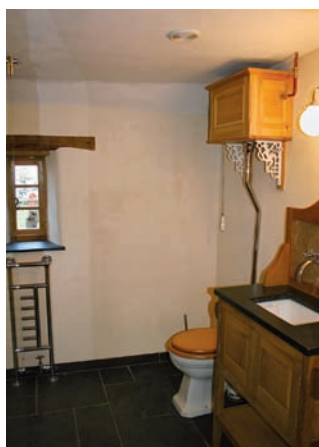
Completed room showing Victorian copy cistern cover and magnolia limewashed walls

The ceiling was decorated with Earthborn breathable claypaint after lime putty filler was used on minor historic cracking. The walls were decorated with good old traditional, breathable and inexpensive limewash. The colour chosen was magnolia, a subtle and warm colour.
